Hastings District Council (HDC) engaged Resource Development Consultants Ltd (RDCL) to undertake geophysical logging of Brookvale Bore 1.

This letter presents a summary of findings from signals processed so far and interpretative comment on the condition of the well.

APPENDIX A
BH01_WITH GEOLOGY

APPENDIX A
BH01_INTERNAL CONDITION

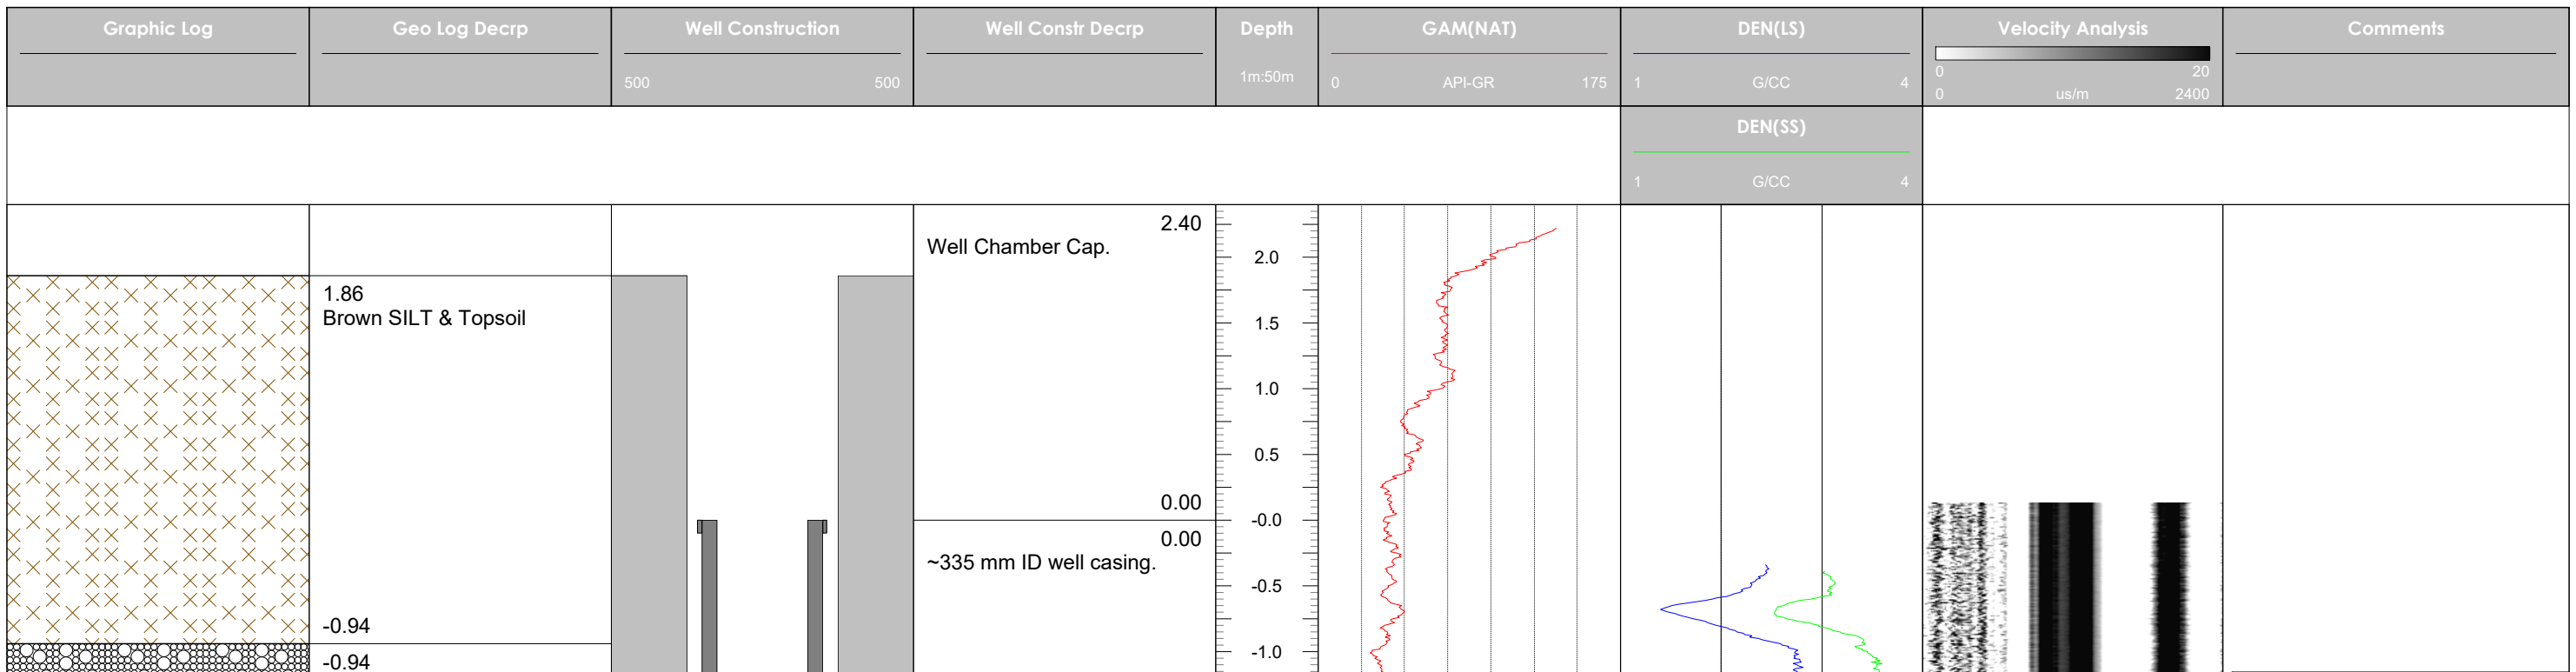
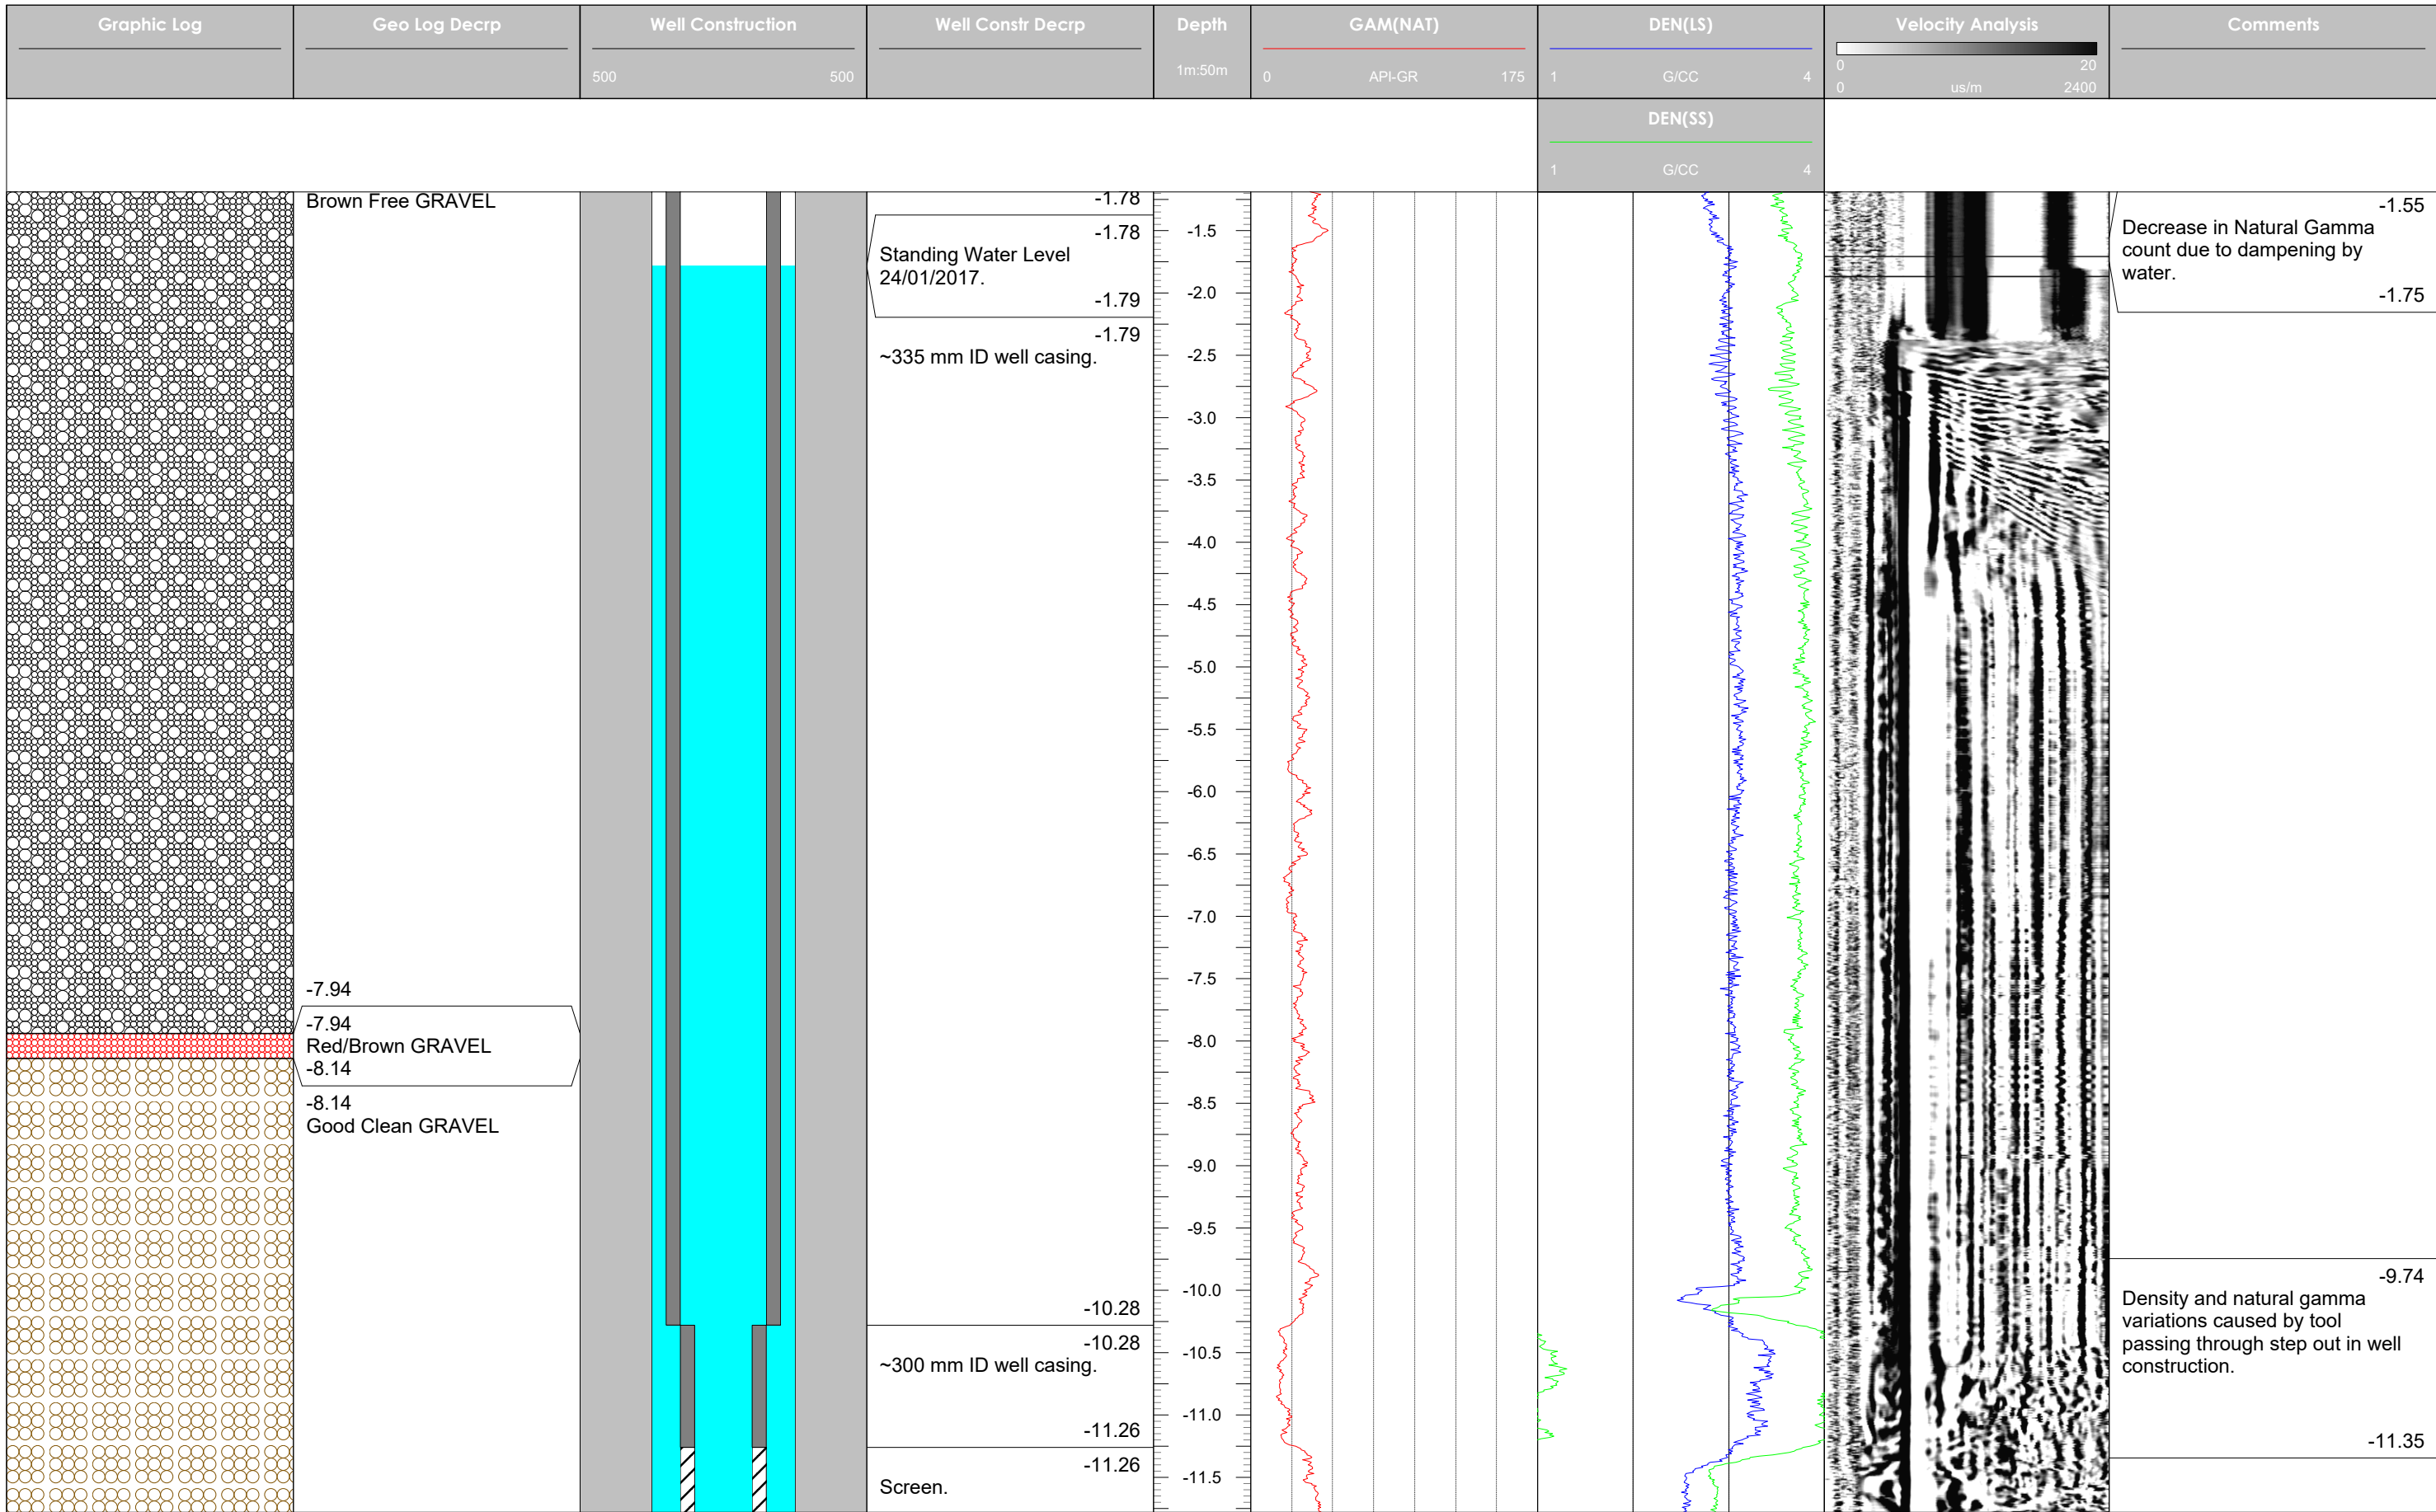
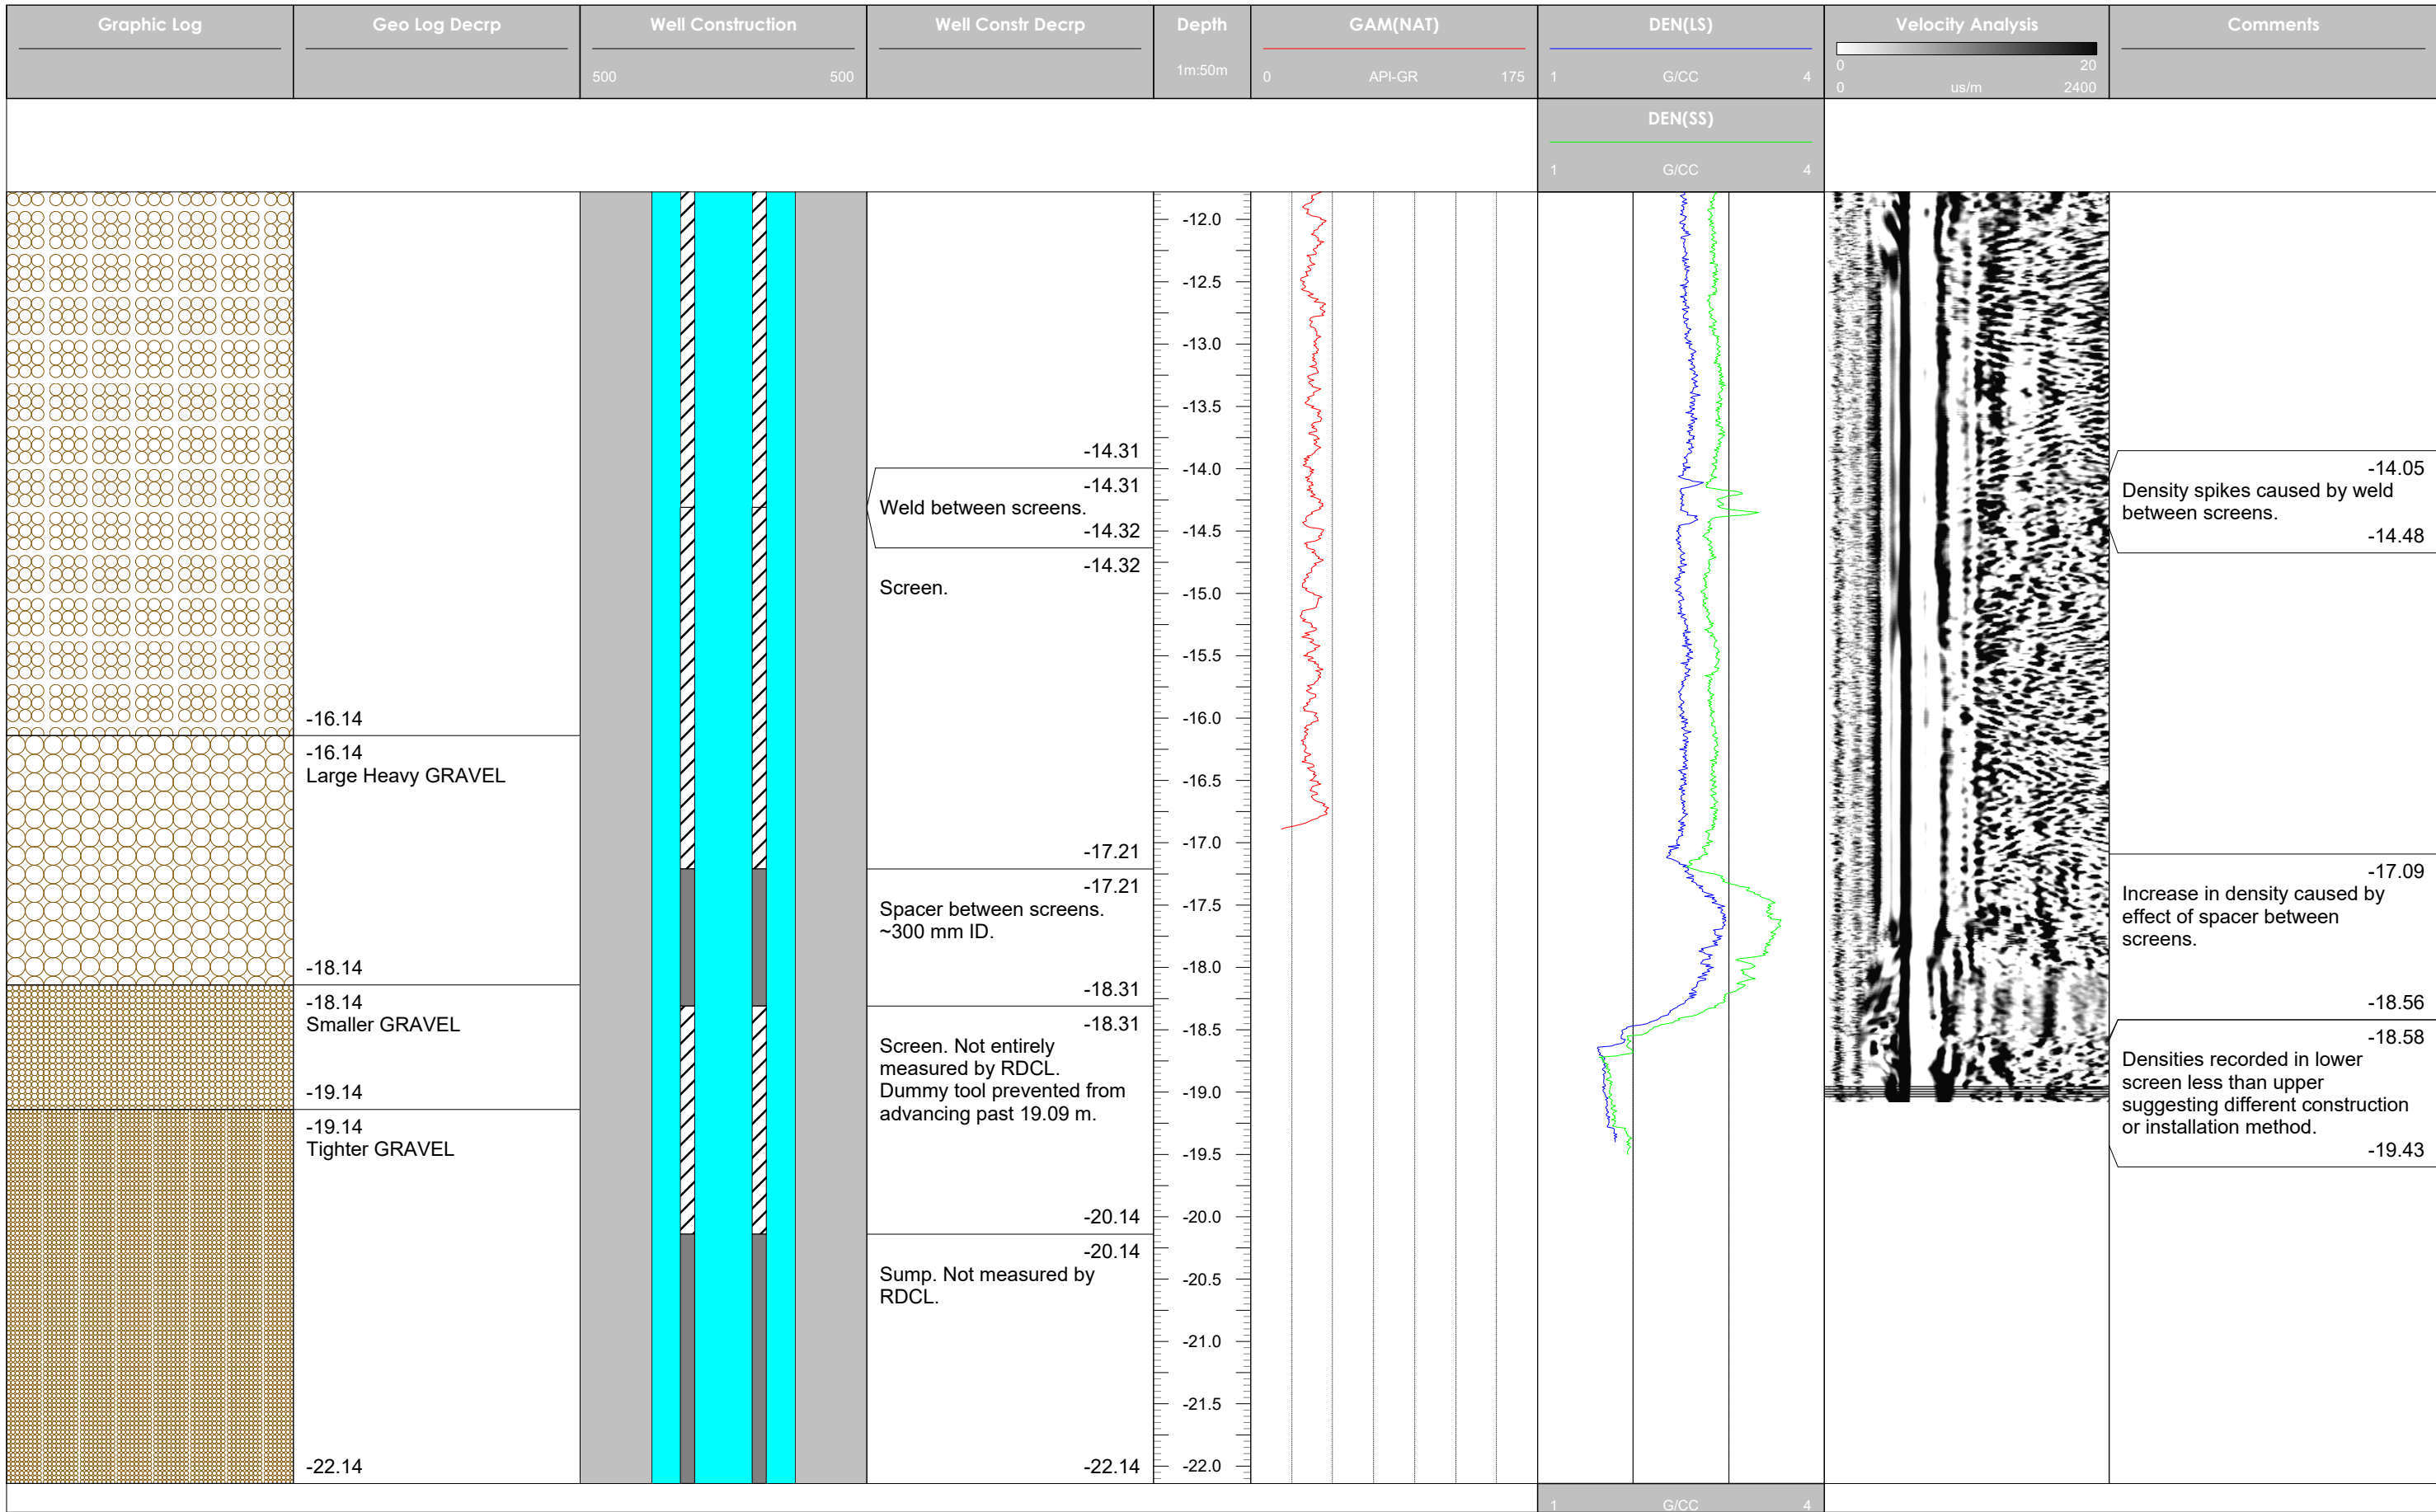
Downhole geophysical survey was completed to 19.09m depth where a partial blockage of the casing prevented the tools from continuing deeper (the full depth of the well from drillers log is 22m with a sump to 24m).

- Casing is continuous with no lengths missing.
- Defects comprise:
 - Rust inside the upper casing (steel) to 11.26m below datum.
 - Electrolysis at screen joints leading to encrustation and partial blockage at 19.09m.
 - No obvious voids behind well casing.

- The as-built record of construction (drillers log) is accurate; and
- There is no evidence of perforation (hole) in the casing, or significant void behind the casing wall.

On the basis of evidence, RDCL expects the casing to perform as designed.
