Hastings District Council (HDC) engaged Resource Development Consultants Ltd (RDCL) to undertake geophysical logging of Brookvale Bore 1.

This letter presents a summary of findings from signals processed so far and interpretative comment on the condition of the well.

APPENDIX A
BH01_WITH GEOLOGY

APPENDIX A
BH01_INTERNAL CONDITION

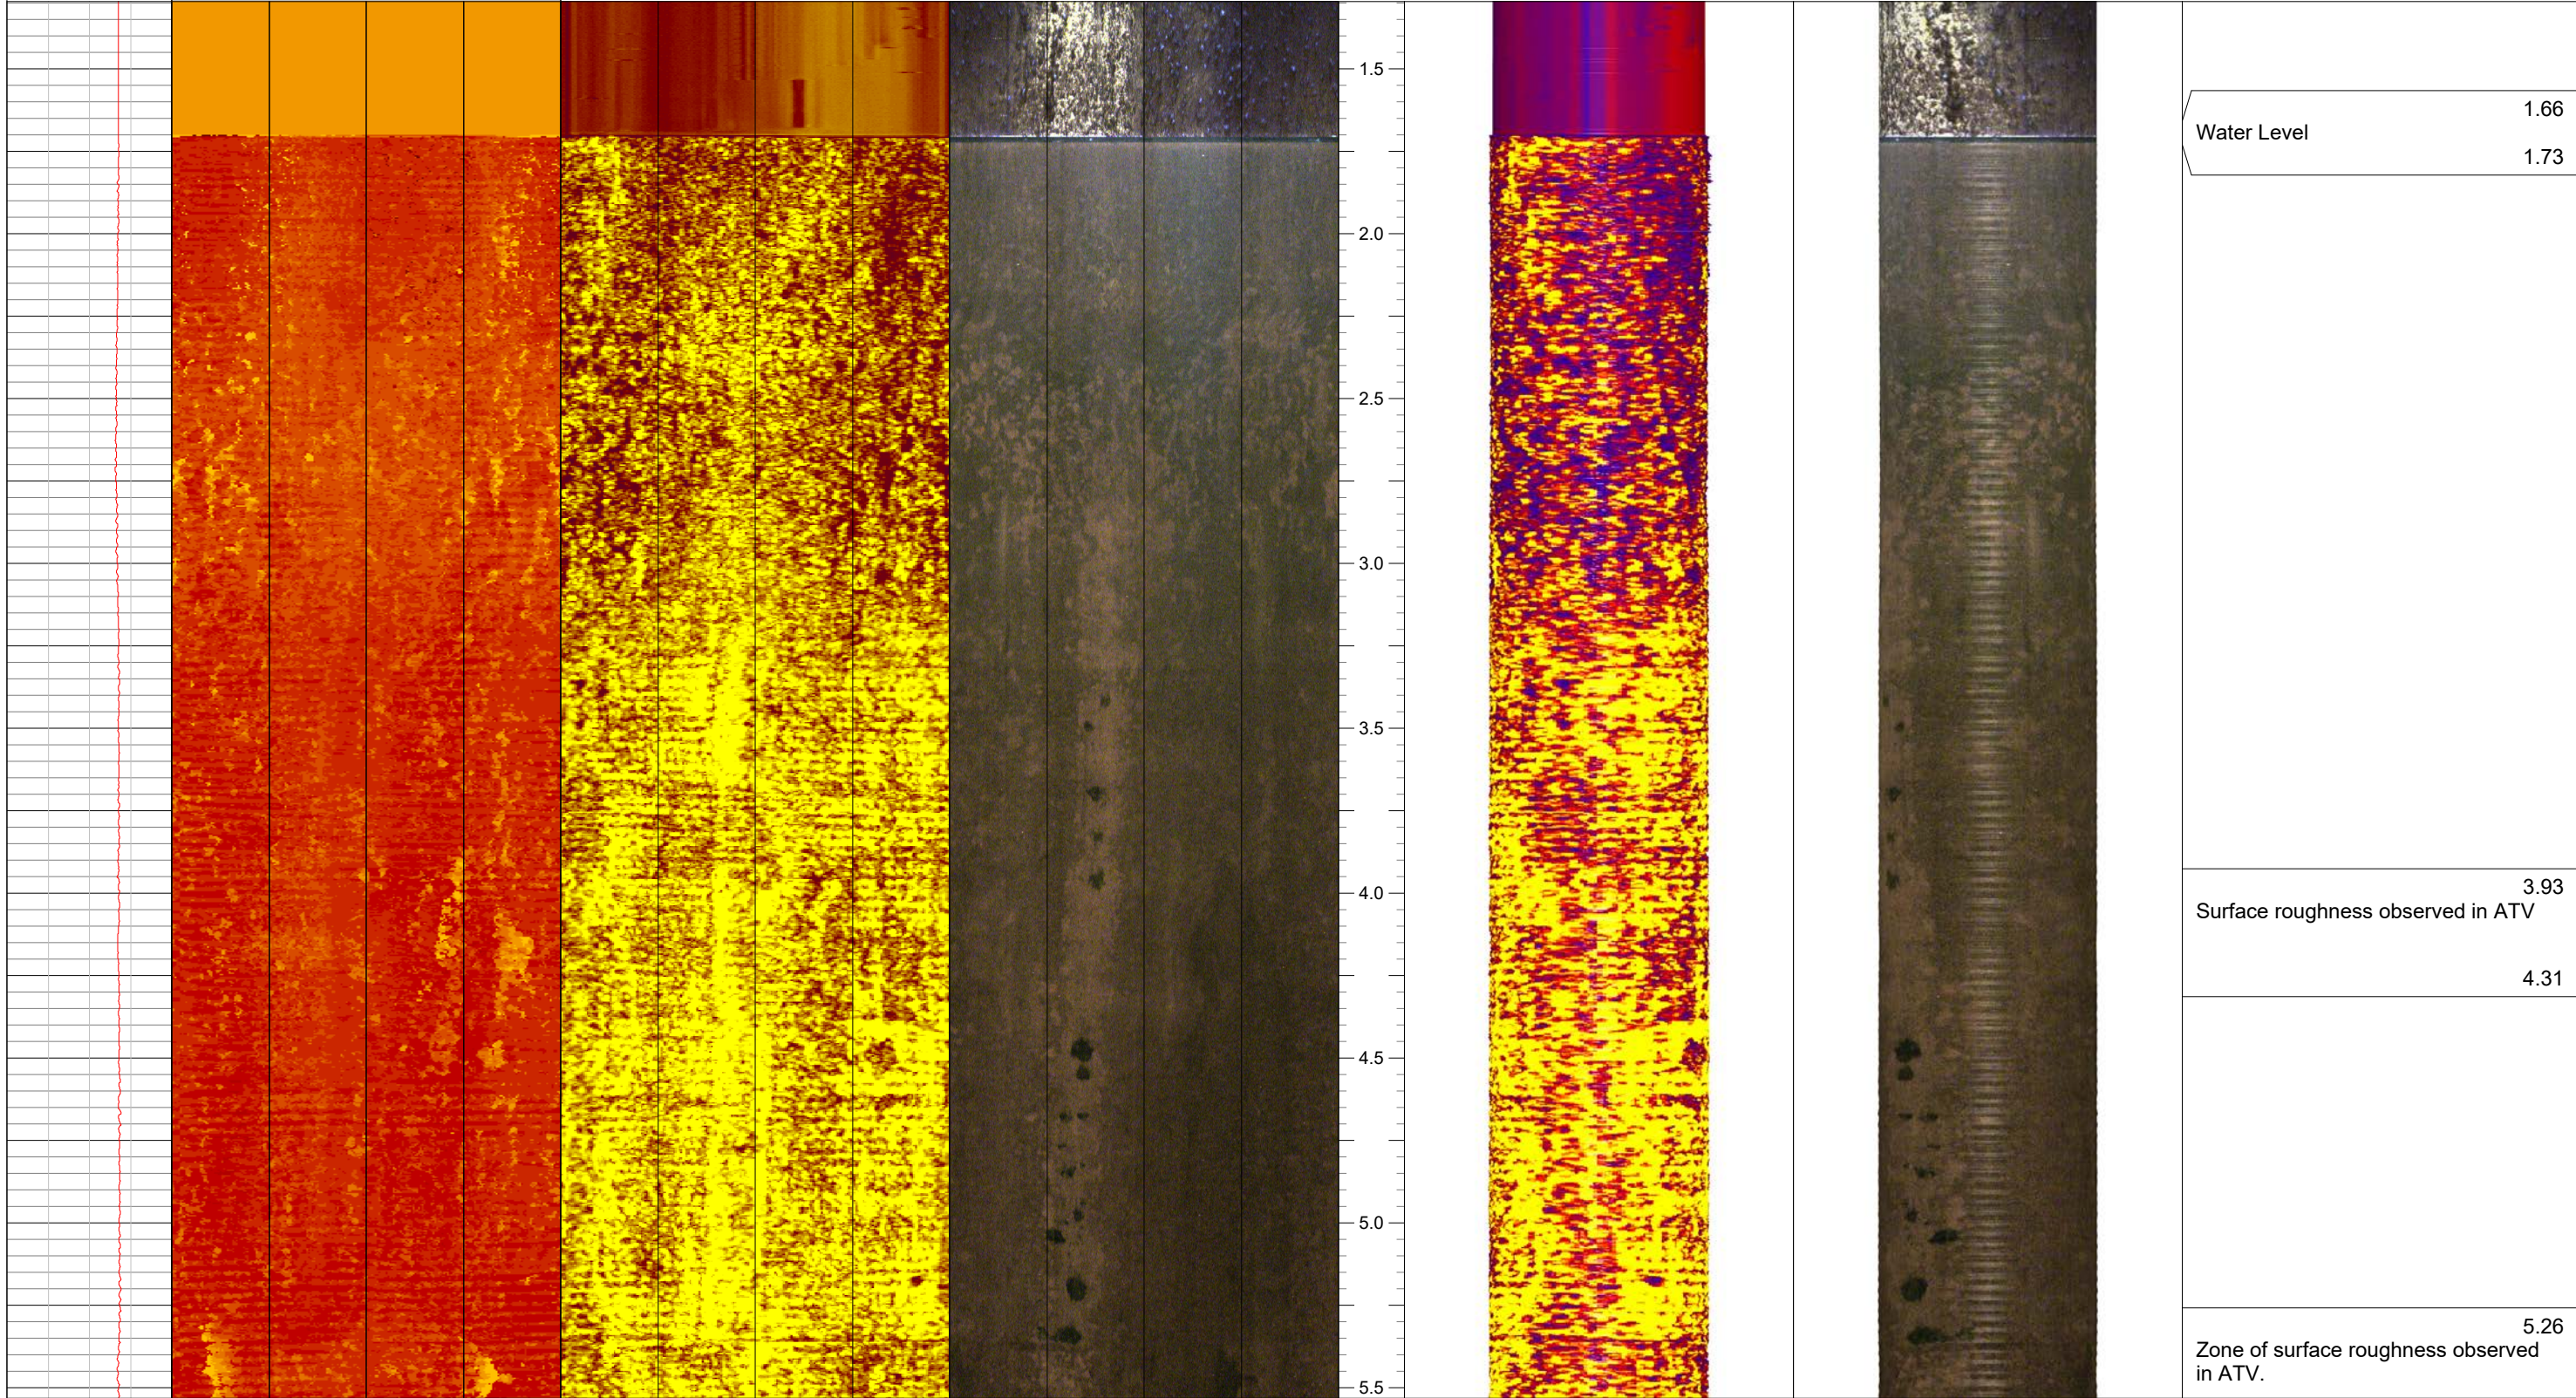
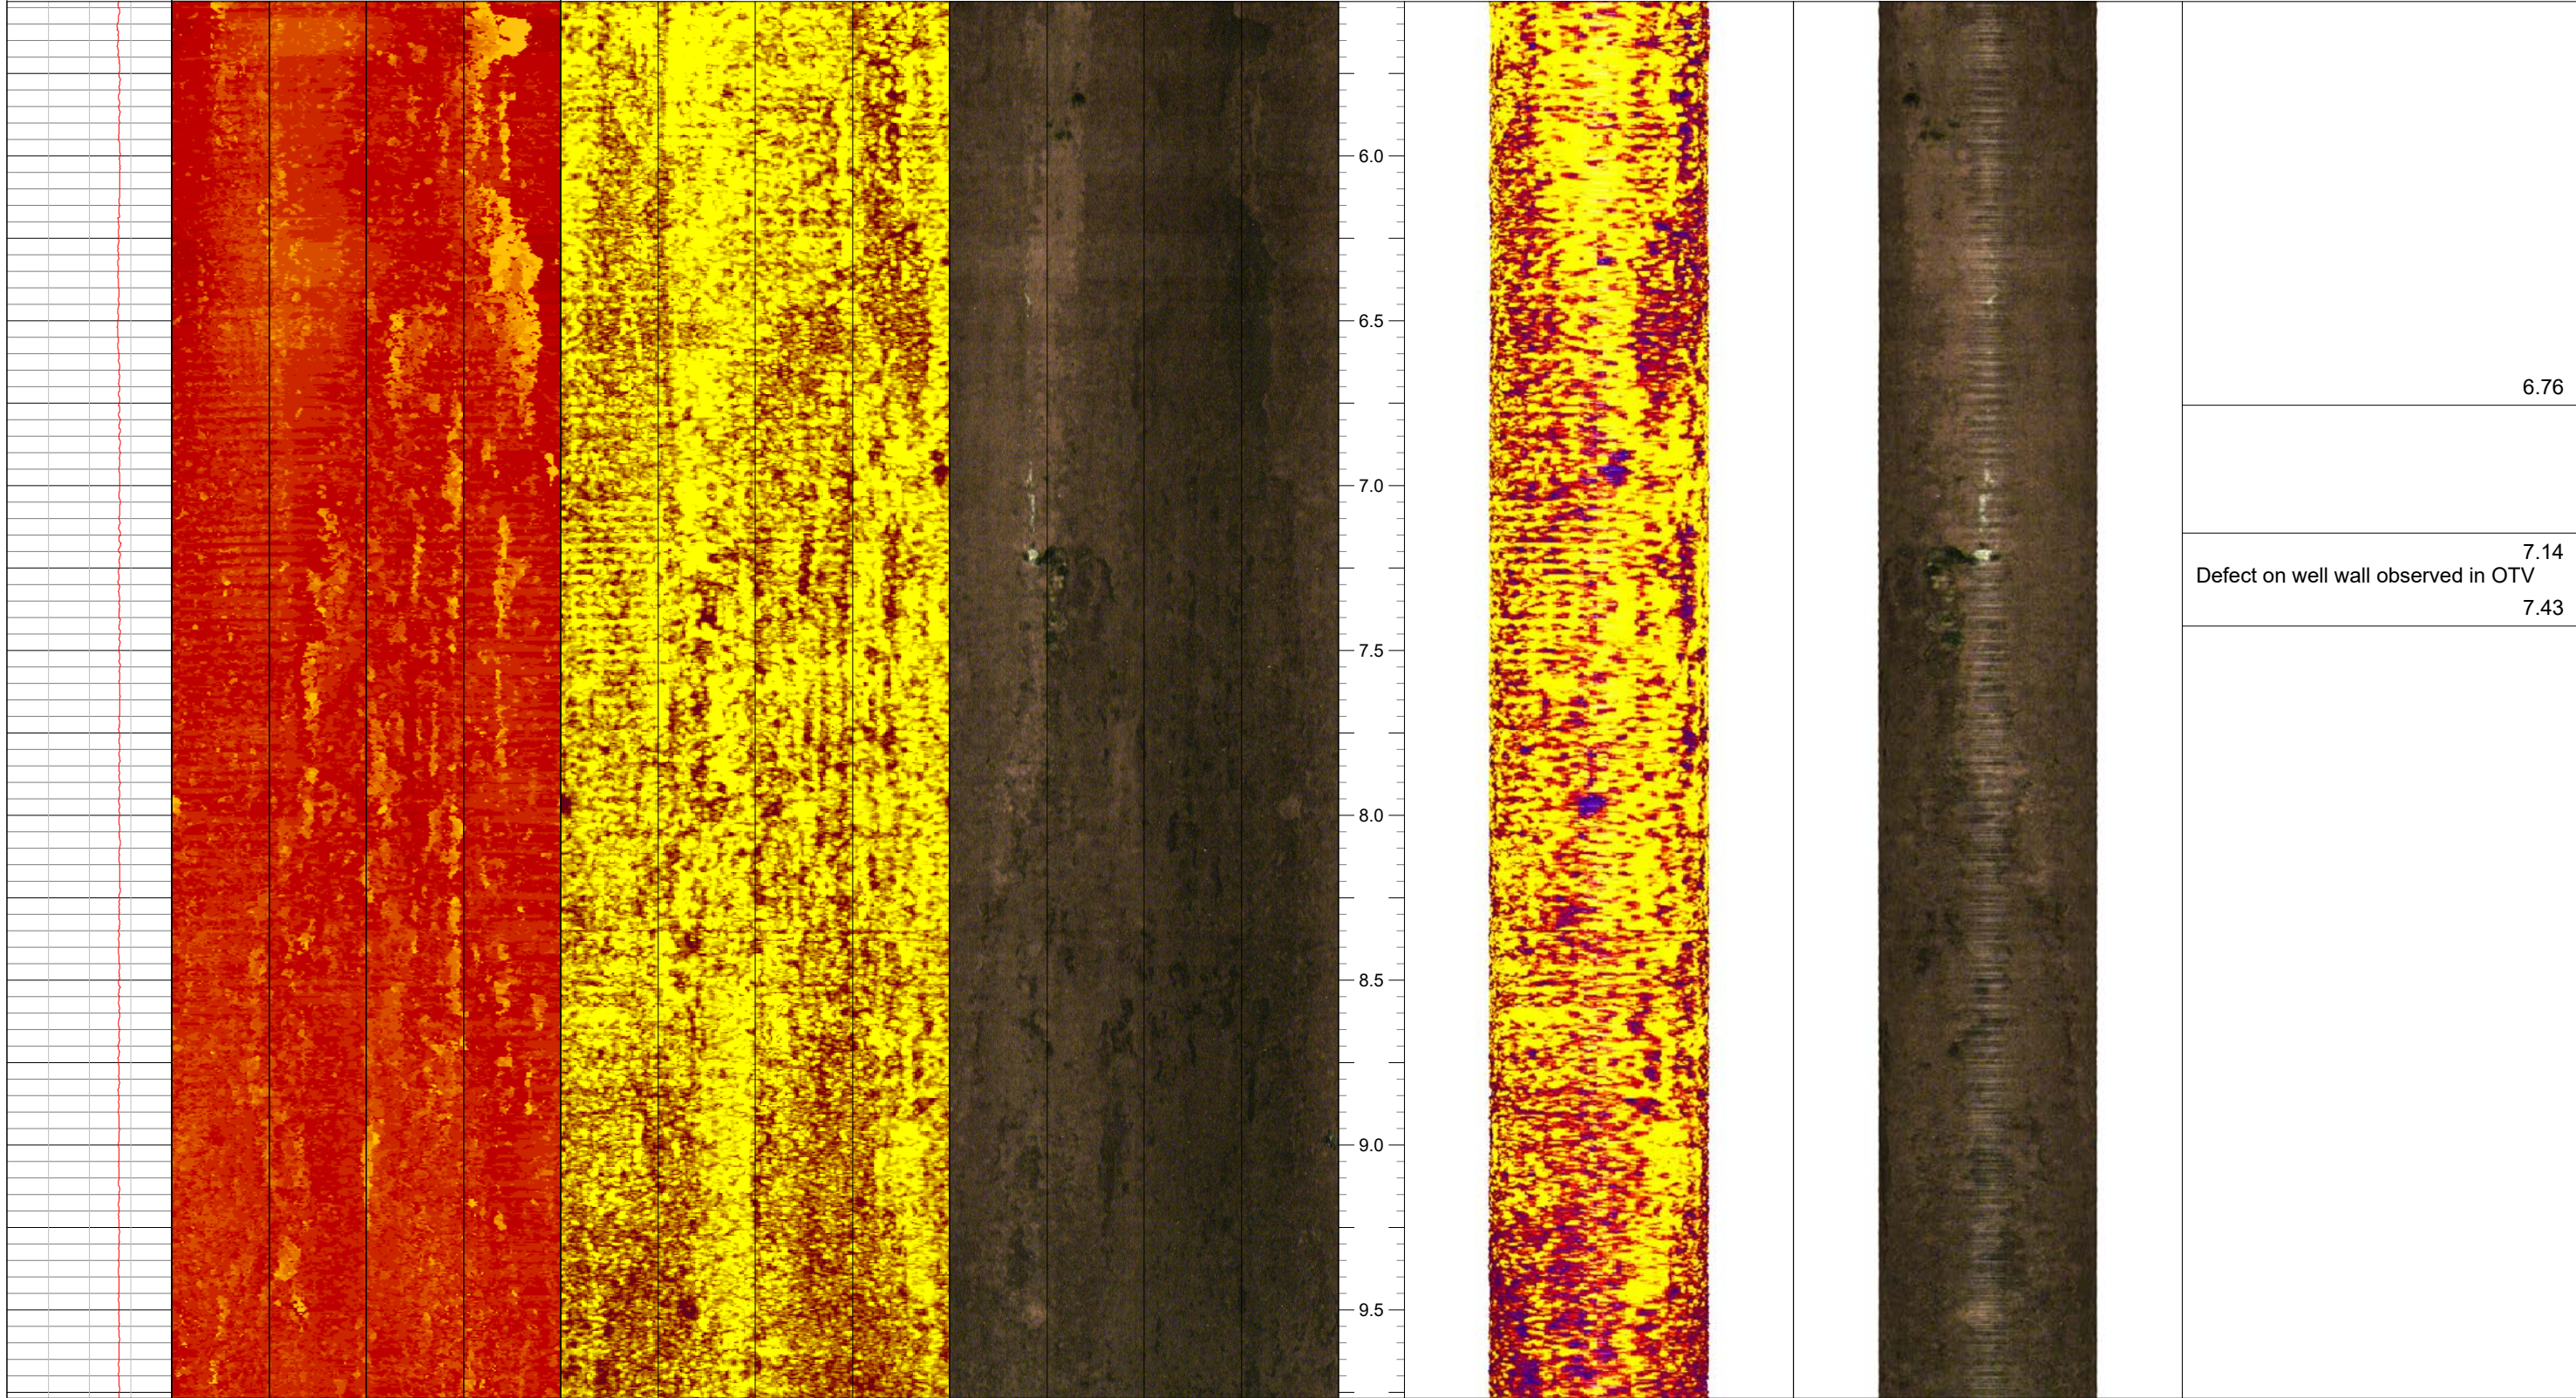
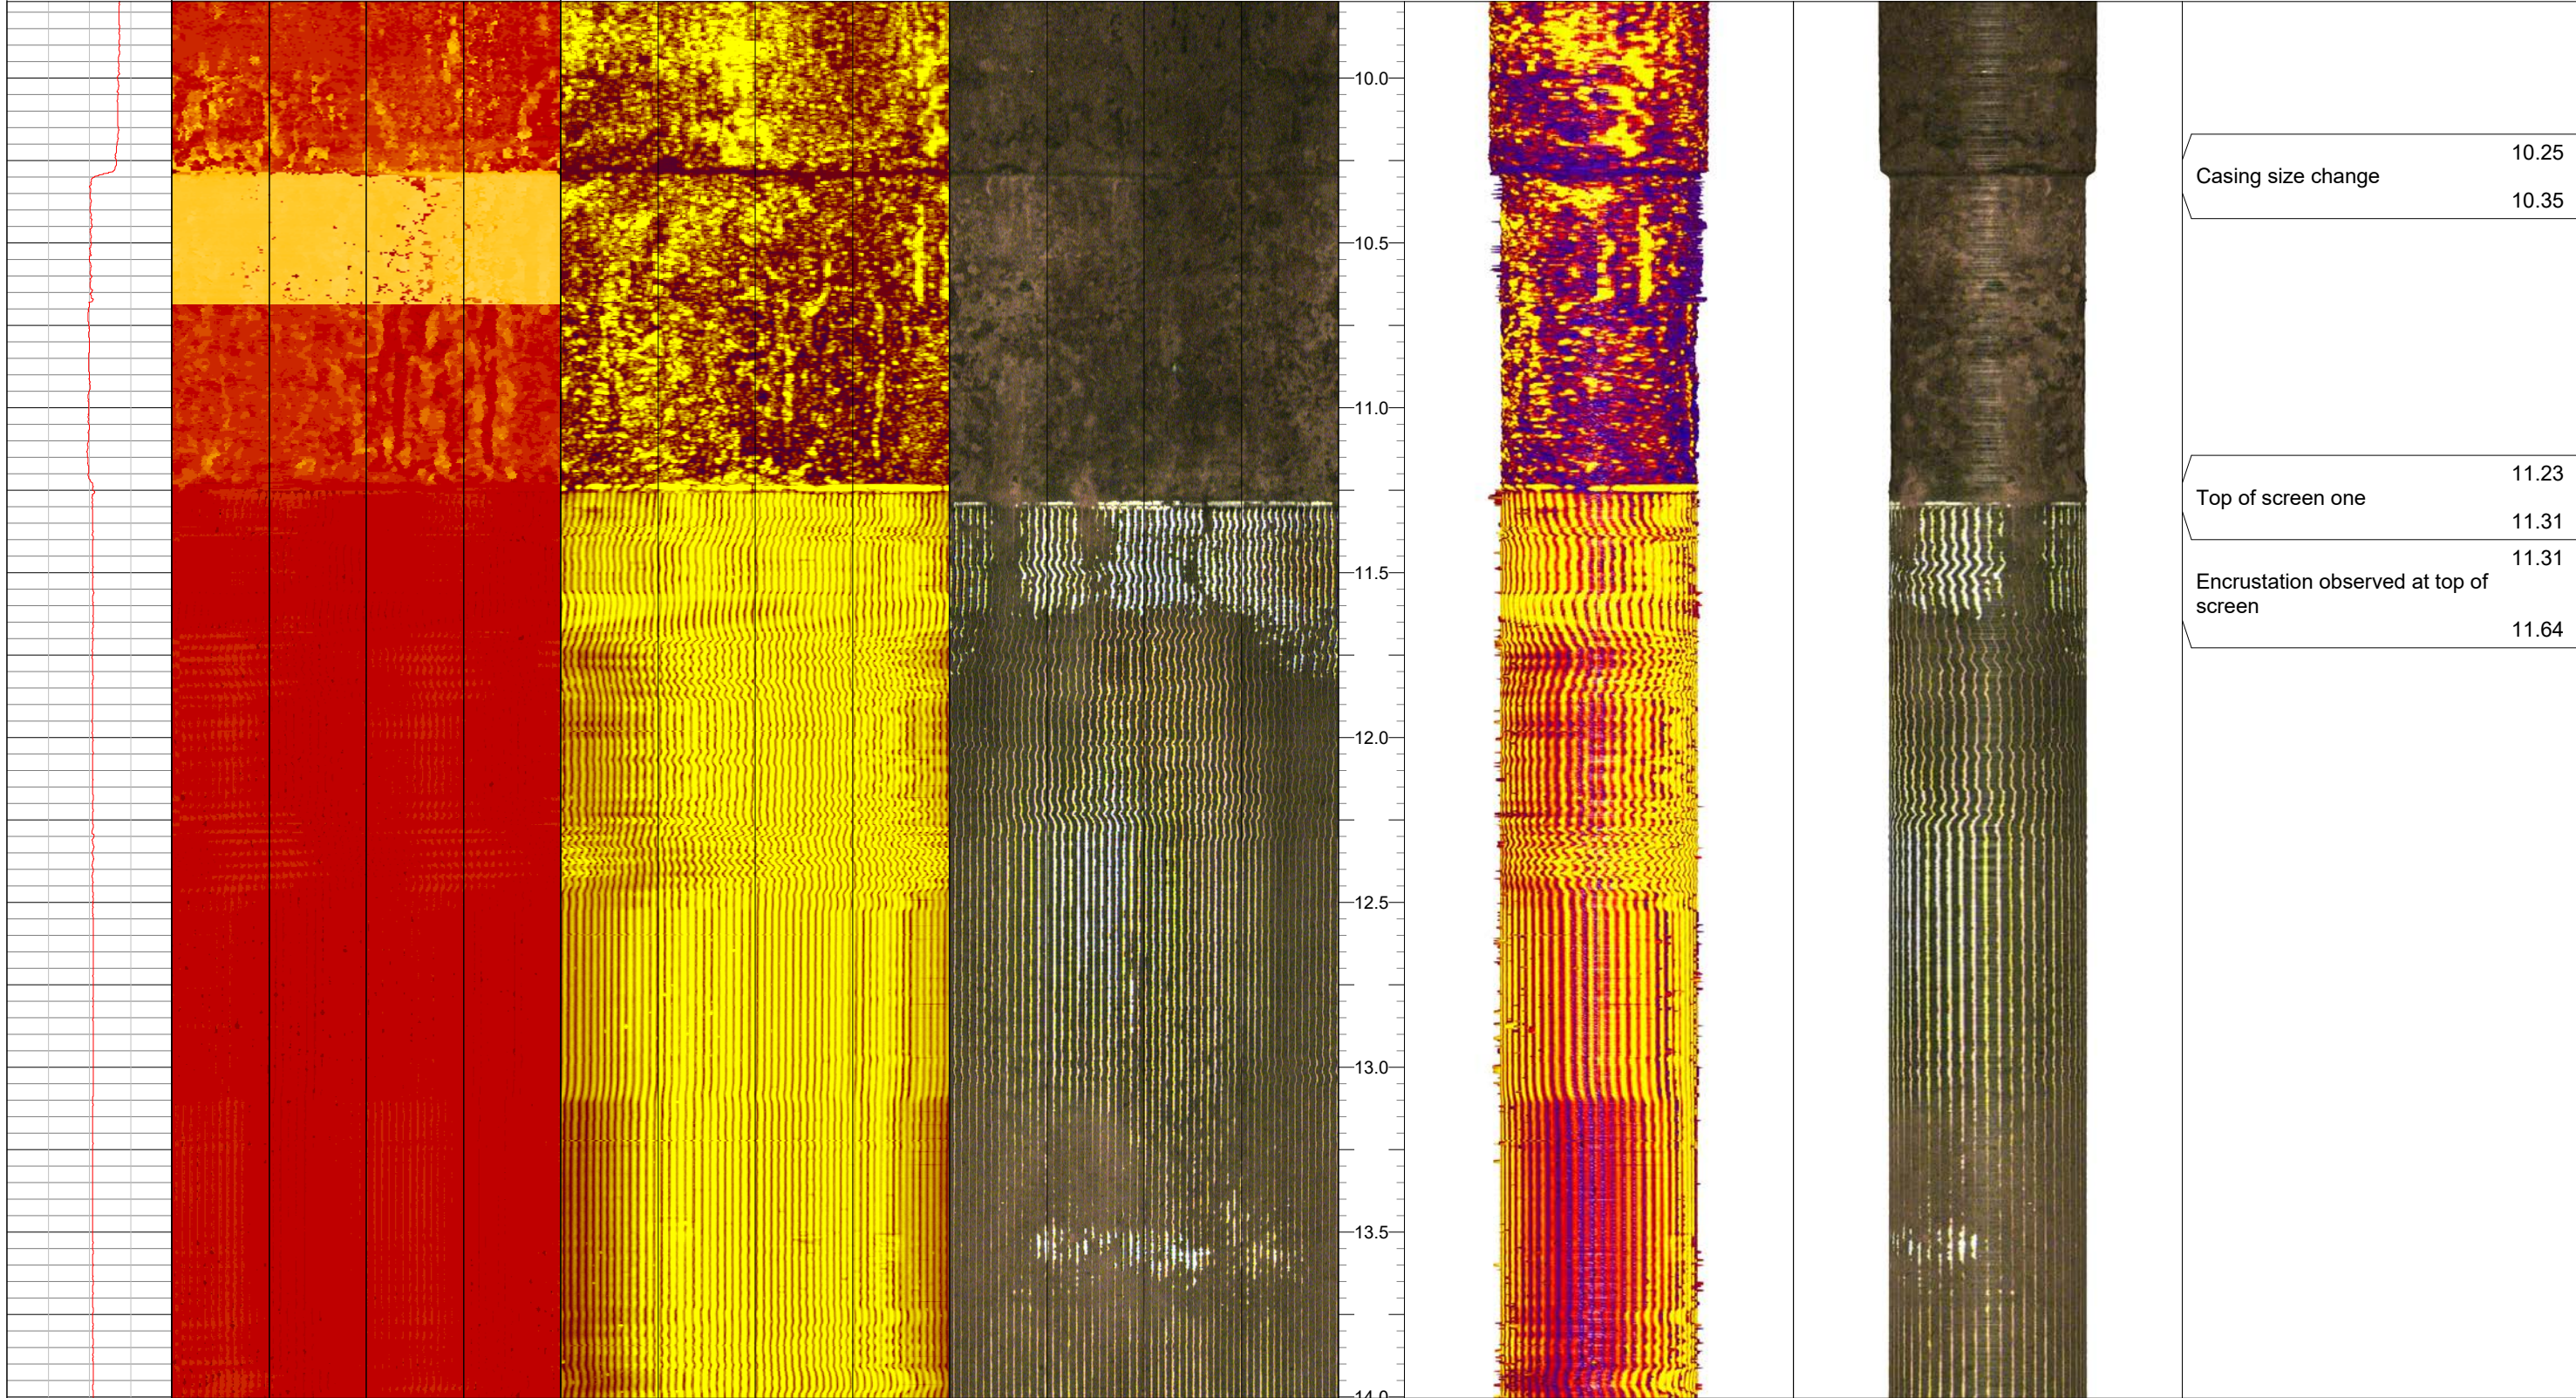
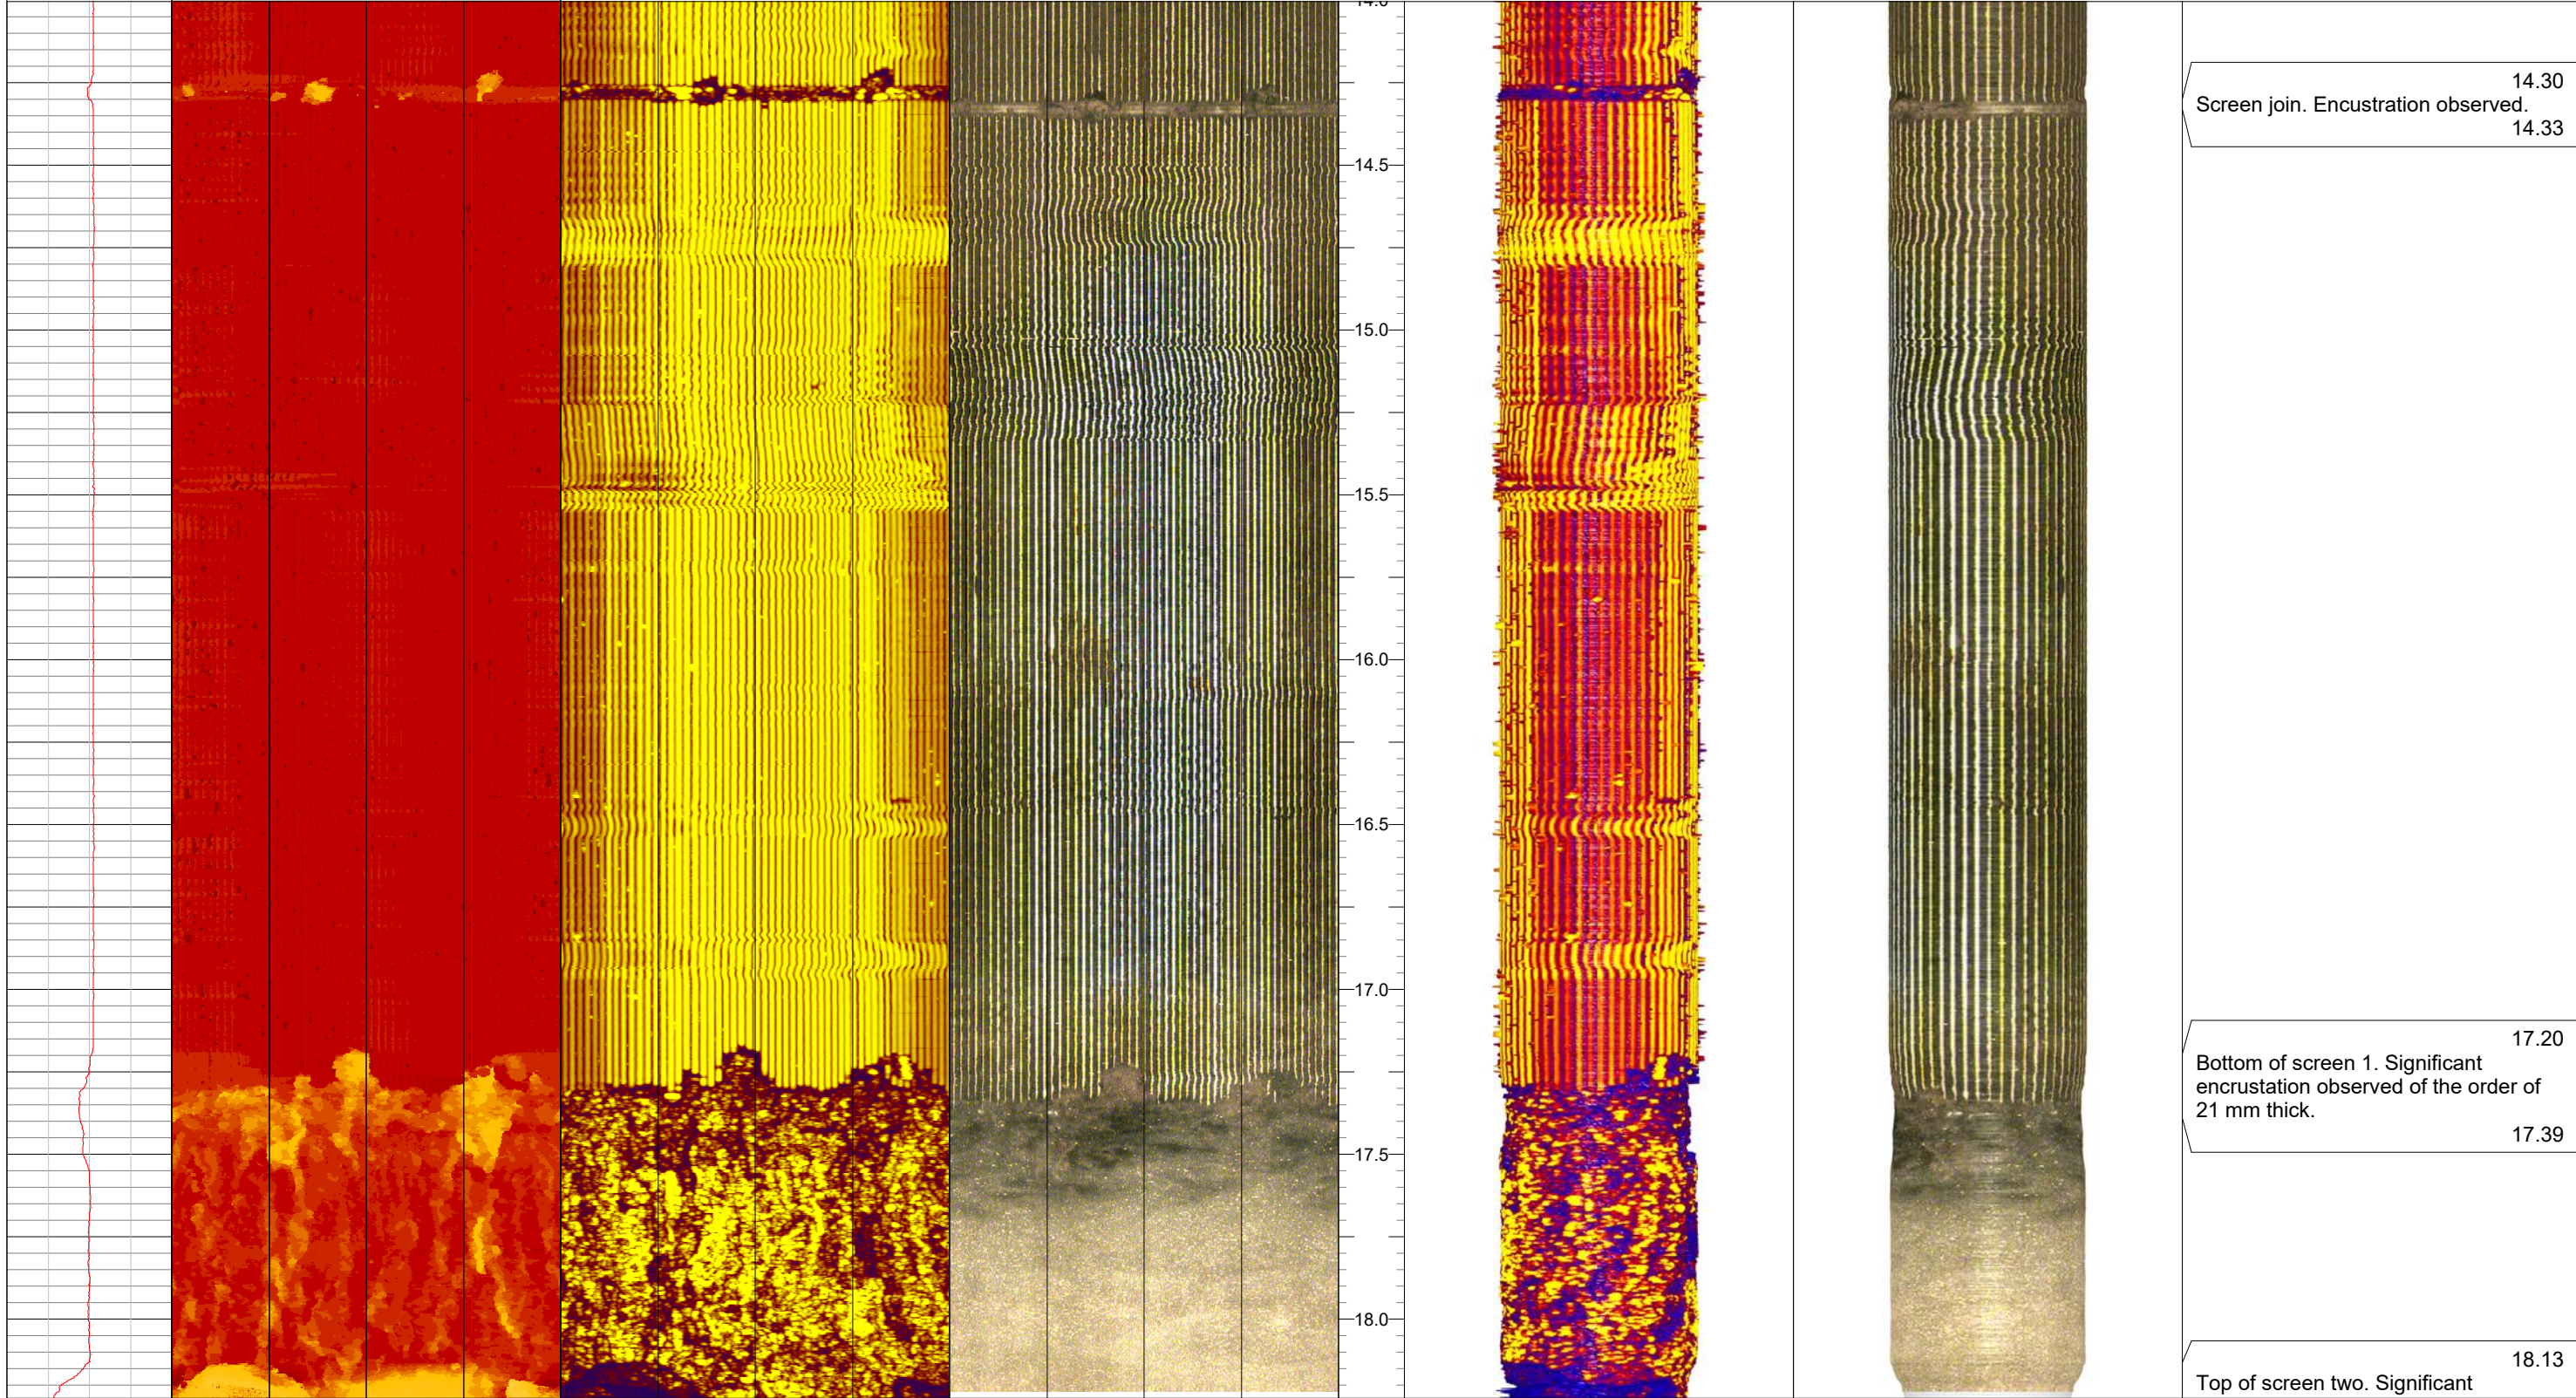
- Casing is continuous with no lengths missing.
- Defects comprise:
 - Rust inside the upper casing (steel) to 11.26m below datum.
 - Electrolysis at screen joints leading to encrustation and partial blockage at 19.09m.
 - No obvious voids behind well casing.

encrustation observed of the order of 53 mm thick. 18.40
200 mm 400	100 mm 200 0° 90° 180° 270° 0° r from Centralized TravelTime - Conditional	0 600 0° 90° 180° 270° 0°	0° 90° 180° 270° 0°	1m:20m	-0°	75°	
Acoustic Calliper_Mer	Caliper from Centralized TravelTime	Amplitude_Merged	Image_edit	Depth	3D Acoustic	3D Optical	Comments
